Monitoring Data Record

Project Title: U-2524AC Site 1 COE Action ID: 200321137
 Stream Name: UT No. 9 to Bull Run DWQ Number: 030909
 City, County and other Location Information: Greensboro Western Loop, Guilford Co.
 Sta. 57+80 Lt. to 58+57 Rt. -L-
 Date Construction Completed: Water was turned into the stream on June 2005 and planted in March 2005. Monitoring Year: (2) of 5
 Ecoregion: _____ 8 digit HUC unit 03030002
 USGS Quad Name and Coordinates: _____
Rosgen Classification: _____ **Proposed reach is a E5 stream type**
 Length of Project: 198' Urban or Rural: Urban Watershed Size: _____
 Monitoring DATA collected by: M. Green & J. Young Date: 2/15/07
 Applicant Information:
 Name: NCDOT Roadside Environmental Unit
 Address: 1425 Rock Quarry Road Raleigh, NC 27610
 Telephone Number: (919) 861-3772 Email address: mlgreen@dot.state.nc.us
 Consultant Information:
 Name: _____
 Address: _____
 Telephone Number: _____ Email address: _____

UT No. 9 to Bull Run

Year 2 Winter – February 2007

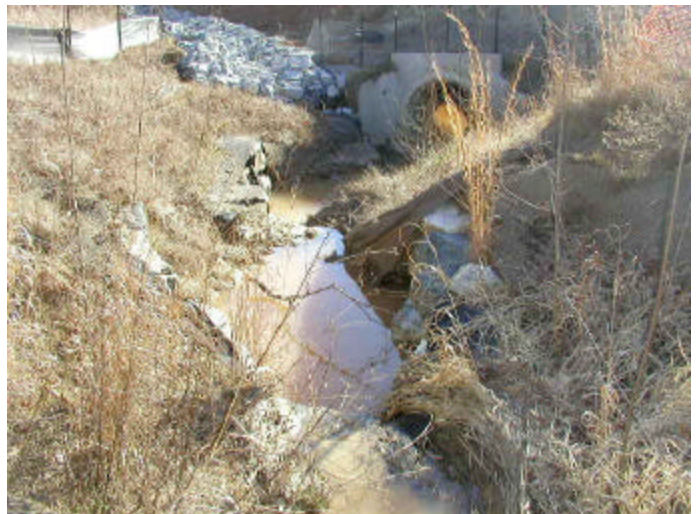
Photo Point #3 (Downstream)

This is the Year 2 winter evaluation of this stream relocation. The stream is stabilized at this time. Some minor bank erosion still exist below a crossvane (Photo Point #3 Downstream) but is not affecting the overall stability of the stream relocation.

Date Inspected	Sta. 58+20-L-	Station Number	Station Number	Station Number	Station Number
Structure Type					
Is water piping through or around structure?					
Head cut or down cut present?					
Bank or scour erosion present?	Minor Bank Erosion
